**Flood Control Project Maintenance  
Levee Inspections****LMA District Cover Sheet  
Spring 2014 Levee Inspection Results****Sutter Maintenance Yard Maintenance Area 0016**

**Spring 2014 Levee Inspection Results**

**Sutter Maintenance Yard Maintenance Area 0016**

Waterway			Bank	Unit Miles
Unit No. 01 Feather River			Right	4.09
	Spring (March - May)	Summer (June - August)	(September - November) Fall	Winter (December - February)
Unit Maintenance Rating (Fall Only)				
Date of Inspection	03/18/2014 - 03/18/2014			
DWR Inspector	Matthew Hoffman			
Accompanied By	Jason Cooper Sutter Maintenance Yard

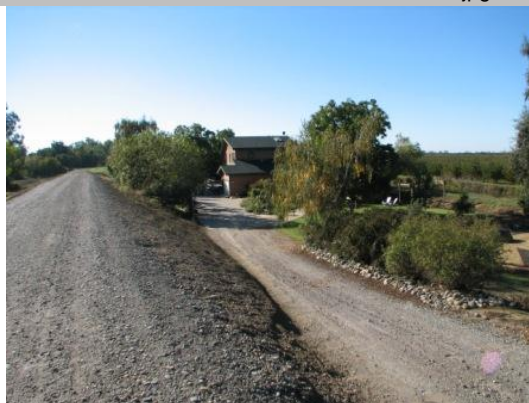
Photo 1 of 1 : mhoffman\_s\_20140306\_089.jpg

LM Start	0.06	Rating **	M	Issue No.	2
LM End	0.10	Issue Type +	En	Location *	LS
Category	Earthen Levee			GPS Latitude/Longitude	
				Start	End
Item	Vegetation			39.256618 °	39.257228 °
				-121.636442 °	-121.636462 °
DWR ID	DWR_MA0016_01_s _ 2012_2				
Action/Comments					
Landscaping

Levee mile 0.10. This photo shows the landscaping on the landside slope and toe.

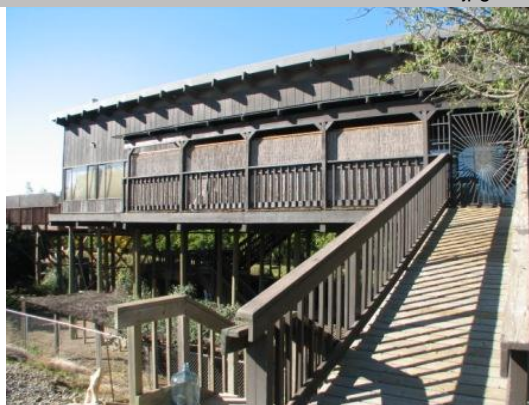
Photo 1 of 1 : mhoffman\_s\_20140306\_093.jpg

LM Start	0.18	Rating **	M	Issue No.	15
LM End	0.18	Issue Type +	En	Location *	LS
Category	Earthen Levee			GPS Latitude/Longitude	
				Start	End
Item	Encroachments			39.258437 °	39.258437 °
				-121.636613 °	-121.636613 °
DWR ID	DWR_MA0016_01_s _ 2012_15				
Action/Comments					
Building

Levee mile 0.18. This photo shows the building on the landside shoulder and toe.

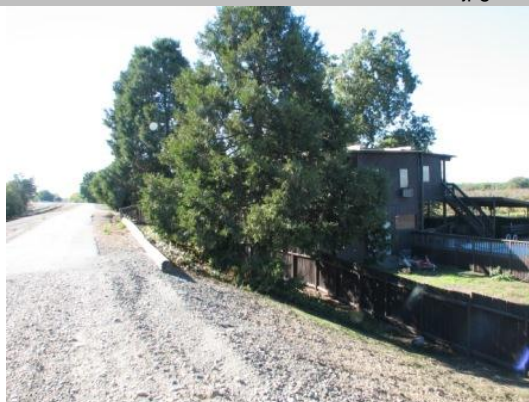
Photo 1 of 1 : mhoffman\_s\_20140306\_090.jpg

LM Start	0.45	Rating **	U	Issue No.	7
LM End	0.49	Issue Type +	En	Location *	LS
Category	Earthen Levee			GPS Latitude/Longitude	
				Start	End
Item	Encroachments			39.262213 °	39.262825 °
				-121.636545 °	-121.636430 °
DWR ID	DWR_MA0016_01_s _ 2012_7				
Action/Comments					
Building

Levee mile 0.49. This photo shows the building and landscaping on the landside slope and toe.

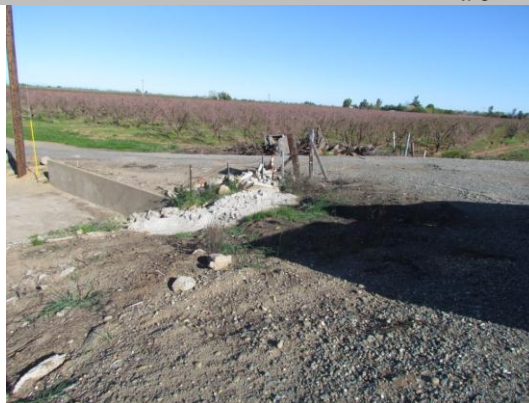
Photo 1 of 1 : mhoffman\_s\_20140320\_267.jpg

LM Start	1.16	Rating **	U	Issue No.	11
LM End	1.16	Issue Type +	En	Location *	LS
Category	Earthen Levee			GPS Latitude/Longitude	
				Start	End
Item	Encroachments			39.272228 °	39.272228 °
				-121.633721 °	-121.633721 °
DWR ID	DWR_MA0016_01_s _ 2014_11				
Action/Comments					
Debris

This photo was taken from the levee crown facing north looking at leftover concrete poured on the landward slope. Spring 2014.

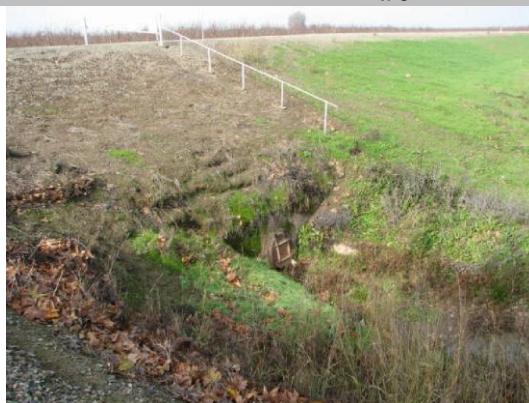
Photo 1 of 1 : UCIP\_3638.jpg

LM Start	1.44	Rating **	M	Issue No.	1
LM End	1.44	Issue Type +	En	Location *	LS
Category	Supplemental			GPS Latitude/Longitude	
				Start	End
Item	DWR UCIP Field Study			39.276170 °	39.276170 °
				-121.632598 °	-121.632598 °
DWR ID	DWR_MA0016_01_s _ 2014_1				
Action/Comments					
Inspector Comments: FS_ID:23766					
EP_NO: N/A					
Repair Type:					
Crossing Status:					
UCIP Comments: Inlet heavily vegetated may need to be cleared					
on 5/14/2013 SBFCA project recommends replacing in accordance					
with title 23/14/2013 Same as last inspection 11/6/2013 Same as					
last inspection.					
FIELD_STRUCT_DESC: 36 inch steel drain pipe approximately 16-feet					
below the crown. Headwall and Model No. 100 flapgate of WS toe.					
Headwall and 24-inch concrete standpipe drop-inlet located					
approximately 1000-feet west of levee crown just on west side of canal.					
O&M Sac 148 Revision: February 2011

WS headwall and flapgate at WS toe.

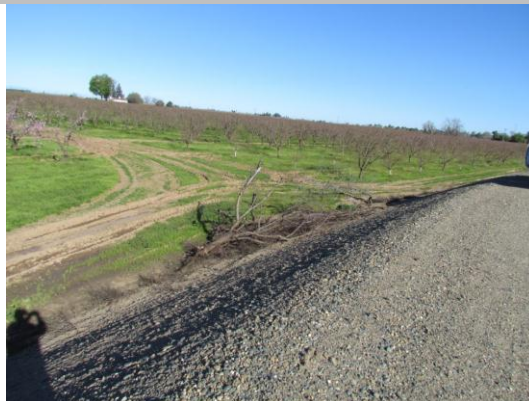
Photo 1 of 1 : mhoffman\_s\_20140320\_268.jpg

LM Start	1.64	Rating **	M	Issue No.	12
LM End	1.64	Issue Type +	En	Location *	LS
Category	Earthen Levee			GPS Latitude/Longitude	
				Start	End
Item	Encroachments			39.278978 °	39.278978 °
				-121.633278 °	-121.633278 °
DWR ID	DWR_MA0016_01_s _ 2014_12				
Action/Comments					
Prunings Inspector Comments: Dead Prune trees placed on landward levee slope. Spring 2014.

This photo was taken from the levee crown facing north looking at prunings and a dead tree placed at the landward levee toe. Spring 2014.

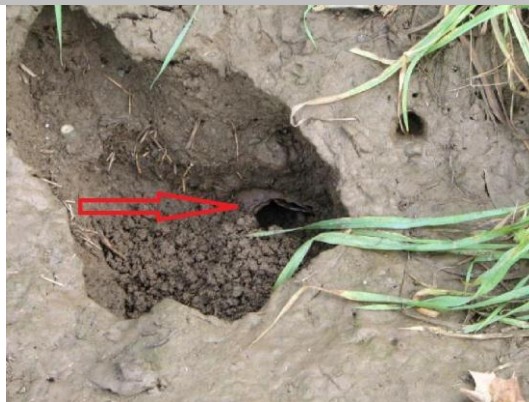
Photo 1 of 1 : UCIP\_5266.jpg

LM Start	1.70	Rating **	M	Issue No.	6
LM End	1.70	Issue Type +	En	Location *	LS
Category	Supplemental			GPS Latitude/Longitude	
				Start	End
Item	DWR UCIP Field Study			39.279812 °	39.279812 °
				-121.632987 °	-121.632987 °
DWR ID	DWR_MA0016_01_s _ 2014_6				
Action/Comments					
Inspector Comments: FS_ID:26393					
EP_NO: N/A					
Repair Type:					
Crossing Status:					
UCIP Comments: Pipe is partially buried at LS toe and shows heavy corrosion. Unable to locate headwalls on either side of levee. Pipe should be cleared of soil and inspected (suspect heavy corrosion throughout pipe). 5/14/2013 SBFCA project recommends replacing in accordance with title 23/14/2013 Same as last inspection. 11/6/2013 Same as last inspection.					
FIELD_STRUCT_DESC: 12-inch CM Storm drain pipe through the levee 14.5 feet below the crown. Slide gate on the waterward end. (O&M entry-As built available 50-4-2193A).					
FS Date: 1/6/2014 9:47:27 AM

Pipe at LS inlet showing heavy silt and corrosion of pipe.

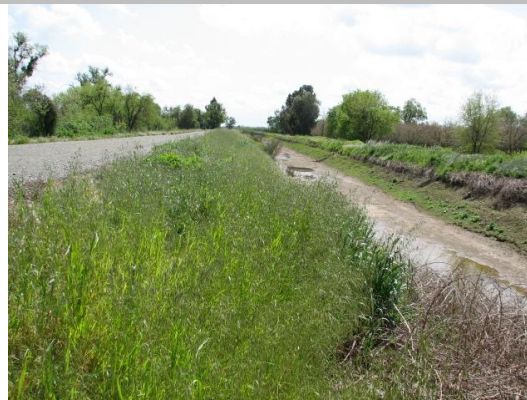
Photo 1 of 2 : mhoffman\_s\_20140306\_091.jpg

LM Start	2.85	Rating **	M	Issue No.	14
LM End	3.08	Issue Type +	En	Location *	LS
Category	Earthen Levee			GPS Latitude/Longitude	
				Start	End
Item	Encroachments			39.293675 °	39.296748 °
				-121.636615 °	-121.638192 °
DWR ID	DWR_MA0016_01_s_2012_14				
Action/Comments					
Ditch

Land side ditch levee mile 3.08.

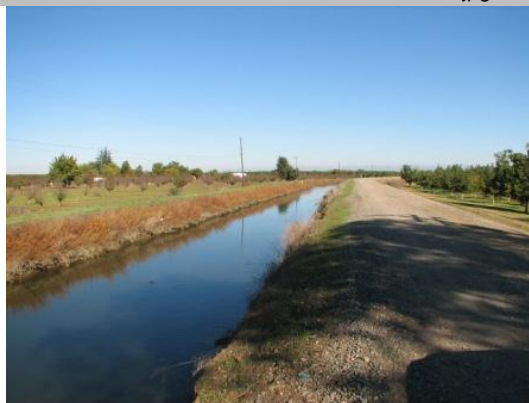
Photo 2 of 2 : mhoffman\_s\_20140306\_092.jpg

LM Start	2.85	Rating **	M	Issue No.	14 (cont)
LM End	3.08	Issue Type +	En	Location *	LS
Category	Earthen Levee			GPS Latitude/Longitude	
				Start	End
Item	Encroachments			39.293675 °	39.296748 °
				-121.636615 °	-121.638192 °
DWR ID	DWR_MA0016_01_s _ 2012_14				
Action/Comments					
Ditch

Agricultural ditch land side slope and toe.

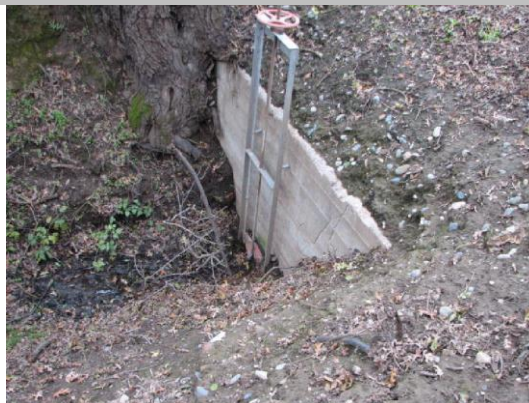
Photo 1 of 1 : UCIP\_3640.jpg

LM Start	2.86	Rating **	M	Issue No.	8
LM End	2.86	Issue Type +	En	Location *	LS
Category	Supplemental			GPS Latitude/Longitude	
				Start	End
Item	DWR UCIP Field Study			39.293774 °	39.293774 °
				-121.636612 °	-121.636612 °
DWR ID	DWR_MA0016_01_s _ 2014_8				
Action/Comments					
Inspector Comments: FS_ID:23772					
EP_NO: N/A					
Repair Type:					
Crossing Status:					
UCIP Comments: Inlet and outlet largely covered in sediment and vegetation. This should be cleared 5/14/2013 SBFCA project recommends replacing in accordance with title 23/14/2013 Same as last inspection 11/6/2013 Same as last inspection.					
FIELD_STRUCT_DESC: 18-inch concrete pipe through the levee approximately 15-feet below the crown. Headwalls on both ends and a Model No. 100 slide gate on WS toe. O&M Sac 148 Revision: February 2011.					
FS Date: 11/8/2013 7:30:12 AM

Slide gate and headwall at WS toe.

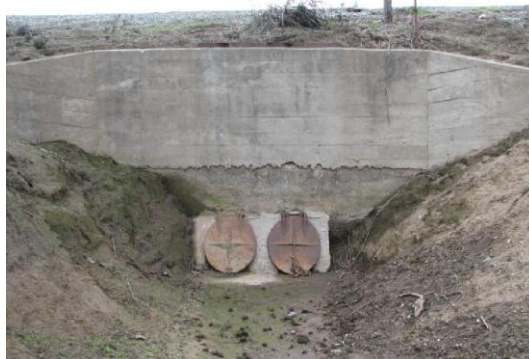
Photo 1 of 1 : UCIP\_3645.jpg

LM Start	3.39	Rating **	M	Issue No.	9
LM End	3.39	Issue Type +	En	Location *	LS
Category	Supplemental			GPS Latitude/Longitude	
				Start	End
Item	DWR UCIP Field Study			39.301218 °	39.301218 °
				-121.638332 °	-121.638332 °
DWR ID	DWR_MA0016_01_s_2014_9				
Action/Comments					
Inspector Comments: FS_ID:23774					
EP_NO: N/A					
Repair Type:					
Crossing Status:					
UCIP Comments: Pipe burried on LS toe and should be inspected along with adjacent 24-inch once uncovered 5/14/2013 SBFCA project recommends replacing in accordance with title 23/14/2013 Same as last inspection 1/6/2013 Same as last inspection.					
FIELD_STRUCT_DESC: 2 of 2: 24-inch CMP drain pipe through the levee 16.6-feet below the crown. Headwalls at both ends and a Flap gate on the WS toe.					
FS Date: 11/8/2013 7:31:05 AM

Headwall and flap gate on WS toe.
